# Joint Reactive Monitoring Mission to the Vat Phou and Associated Ancient Settlements within the Champasak Cultural Landscape World Heritage Property Lao People's Democratic Republic

17-21 February 2015

### **MISSION REPORT**

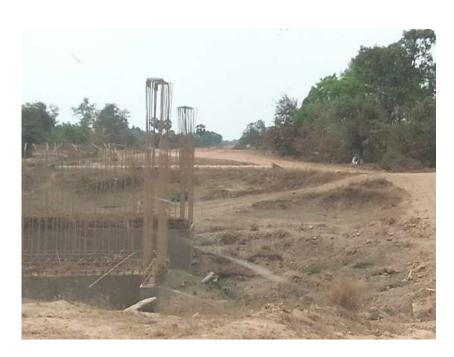
3. Work ceased on Route 14A between Km 29 and Km 34 after preparation of road and construction of supporting pillars of the three bridges (source: M. H. Unakul)

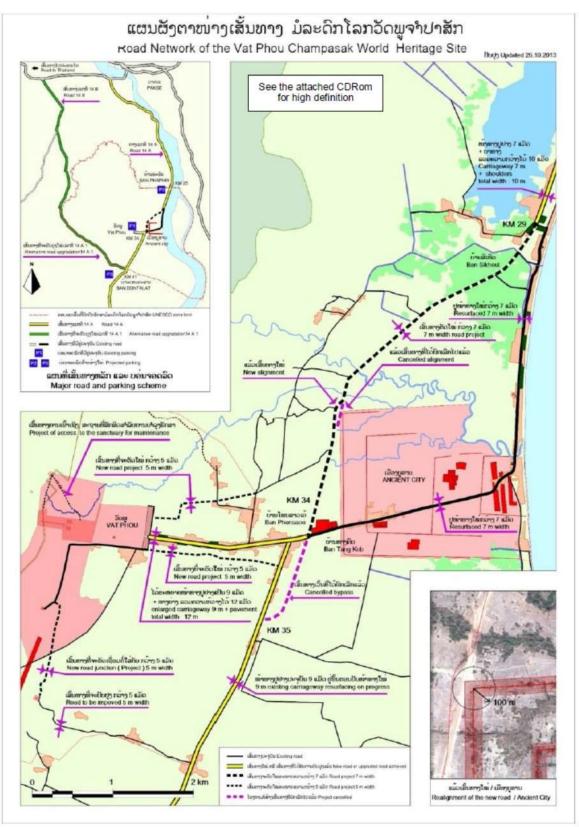
4. Master Plan Map showing Route 14A and district road through Champasak town and Ancient City (source: Vat Phou Champasak World Heritage Site Management Office)

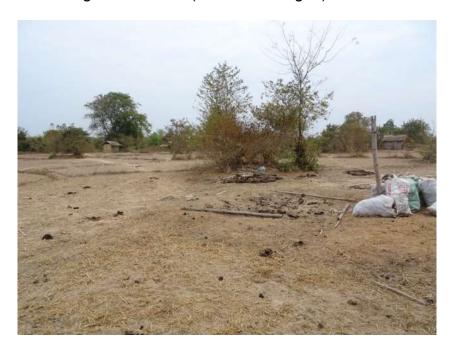
6. Route 14A was planned to run 24 metres from this north -western corner of the fourth enclosure wall of the Ancient City (source: W. Logan).

On the basis of the information provided to the mission, and contingent upon the implementation of Recommendations 1 and 2, Route 14A should be completed according to the original alignment 24 metres from the north-west corner of the fourth enclosure wall of the Ancient City, rather than according to the proposed realignment 100 metres from the corner.

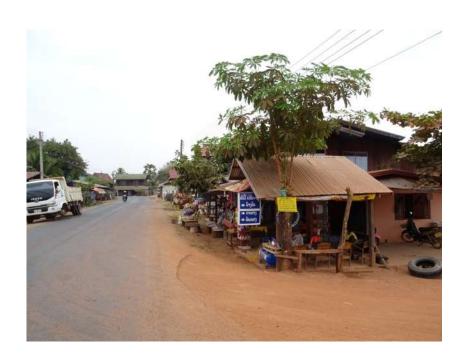
8. Traffic diversion through the Ancient City produces vibrations that may be damaging buried archaeological remains and causing visual, noise and air pollution (source: W. Logan).

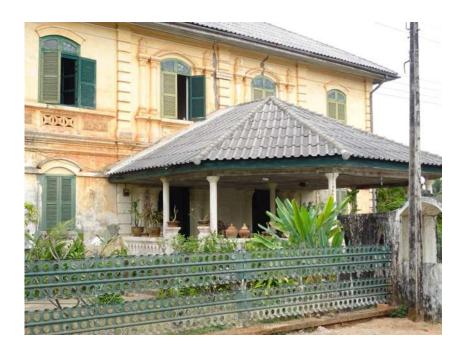
9. Modern addition to a prominent colonial building built in 1926 in Champasak town (source: W. Logan).

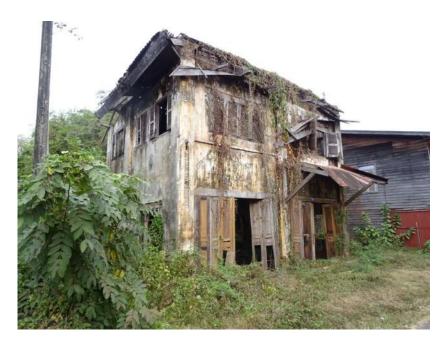
11. One of Champasak town's last remaining colonial-style buildings in derelict condition (source: W. Logan).

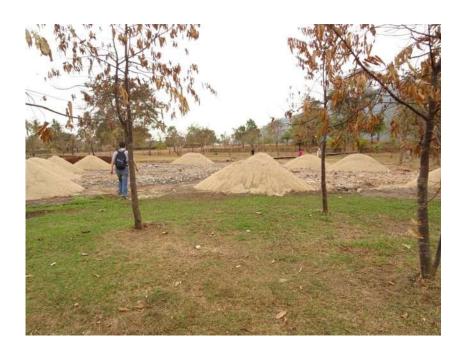
12. Location of the 2003 visitor pavilion destroyed by fire in early February 2015 (source: W. Logan).

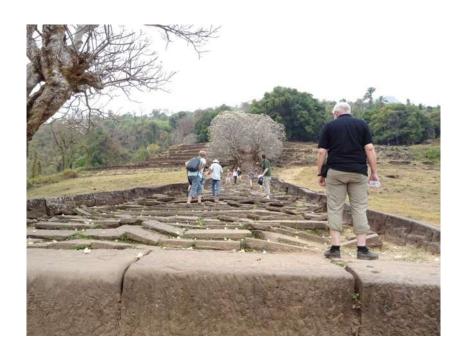
The central Vat Phou path surface, stairs and terraces would benefit from further consolidation (source: W. Logan).

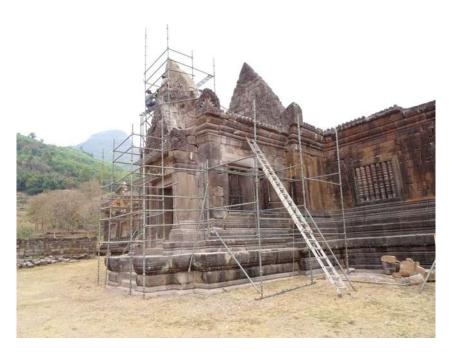
15. Restoration of the North Quadrangle by the India-Laos Cooperation Project is now largely completed (source: W. Logan).

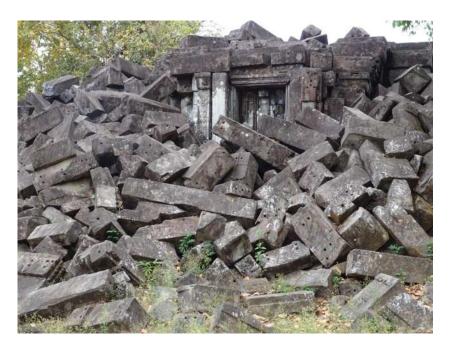
16. Hong Nang Sida is being reassembled in a Korean-funded project (source: W. Logan).

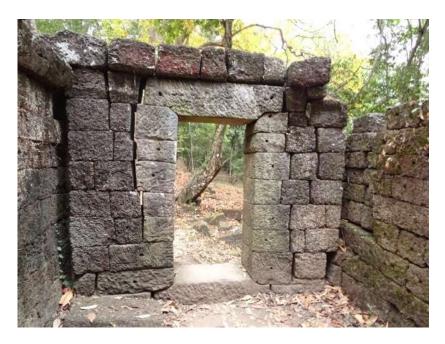
17. Tomo Temple, on the east side of the Mekong, has yet to receive major funding for restoration (source: W. Logan)
